National Highway Traffic Safety Administration

Case Vehicle (A): 2000 Ford Type: Focus, 3-door hatchback

Vehicle (B): 1999 Ford Type: E-350, passenger van Driver: 36-year-old male

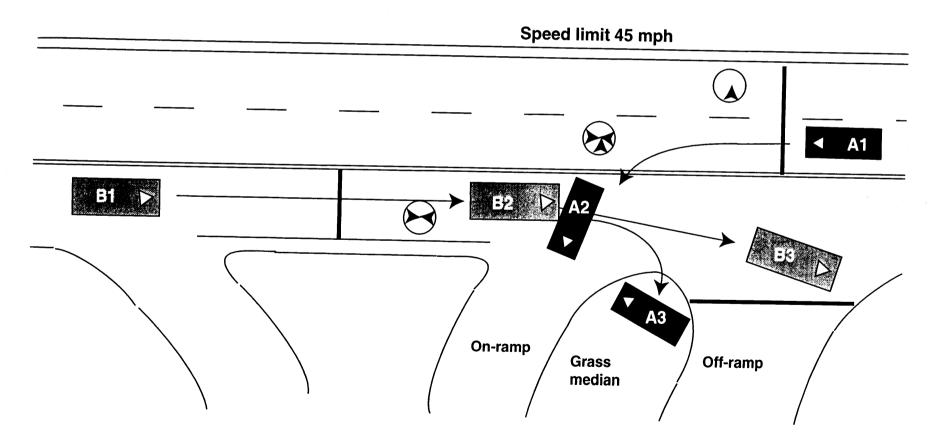
Vehicle (B) was traveling in the single north bound lane, approaching the intersection. As vehicle (B) entered the intersection, the driver of case vehicle(A) made a left turnacross the path of vehicle (B). Vehicle (B) struck the right side of case vehicle (A) NORTH came to rest in the median that separates the on and offramps. After impact, vehicle (B) rotated clackwise slightly, and came to rest in the mouth of the intersection of the 3-lane roadway and the off-ramp.
